# Manhole Inspection Summary

Manhole # S09S\_\_002MH

Insp Date: **11/18/08 10:15 AM**

**Location** Address: **3398 Dulany St.** Cross Street: **Bloomfield Ave.**

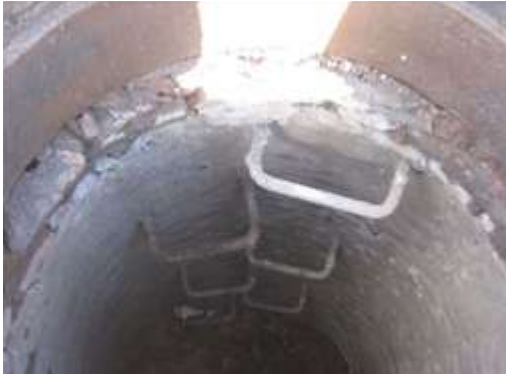
Defect 4

**Frame** Offset: **2** (in.) Condition: ☐ Sound ☐ Cracked ☒ **Leaks**

frame leaks and Frame off set

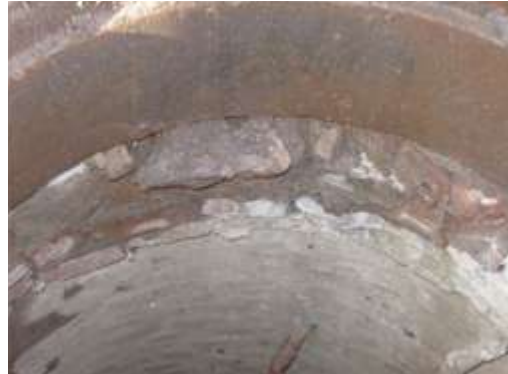
Defect 3

**Chimney / Frame Adjustment** ☒ Exists Material: **Brick** ☐ Parged Height: **3** (in.)  
Condition: ☐ Sound ☐ Cracked ☐ Root Intrusion ☒ **Loose Brick** ☐ Deteriorated  
Infiltration: ☐ None ☐ Joint ☐ Cracks ☒ **Mortar** ☐ Roots ☒ **Wall**

loose bricks at chimney with infiltration

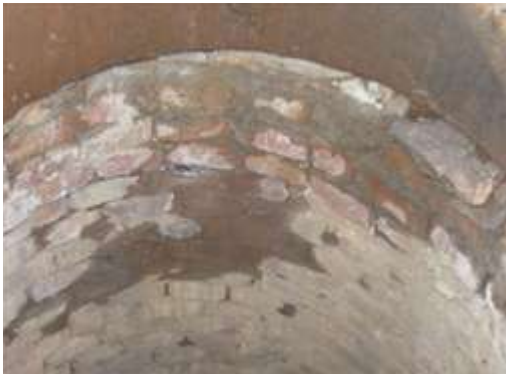
Defect 2

**Corbel** Material: **Brick** ☐ Parged Type: **Concentric/Eccentric**  
Condition: ☒ Sound ☐ Cracked ☐ Root Intrusion ☐ Loose Brick ☐ Deteriorated  
Infiltration: ☐ None ☐ Joint ☐ Cracks ☐ Mortar ☐ Roots ☒ **Wall**

chimney and corbel infiltration

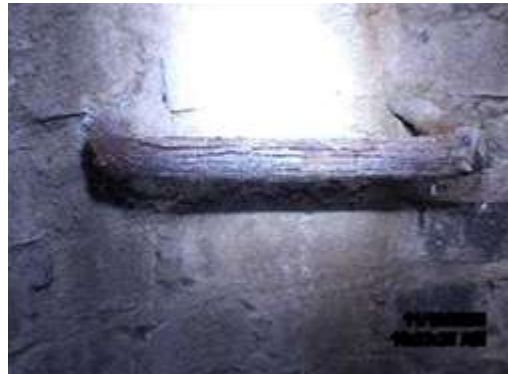
Defect 1

**Steps** Count: **6** Missing: **0** ☒ **Corroded**

corroded steps

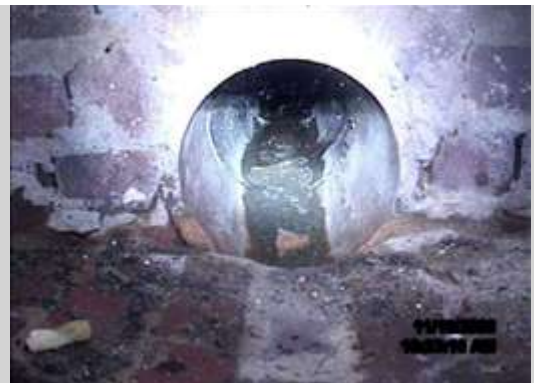
12 O'Clock Outflow

8 in. Circular Gravity Sewer  
Pipe Out @ 12 O'Clock

Infiltration: **None** Pipe Seal Cond: **Sound**
